**PROJECT:** Midnite Mine Remediation

**REPORT NO:** 2019-016

## Summary of Work Activities or Events for this reporting period:

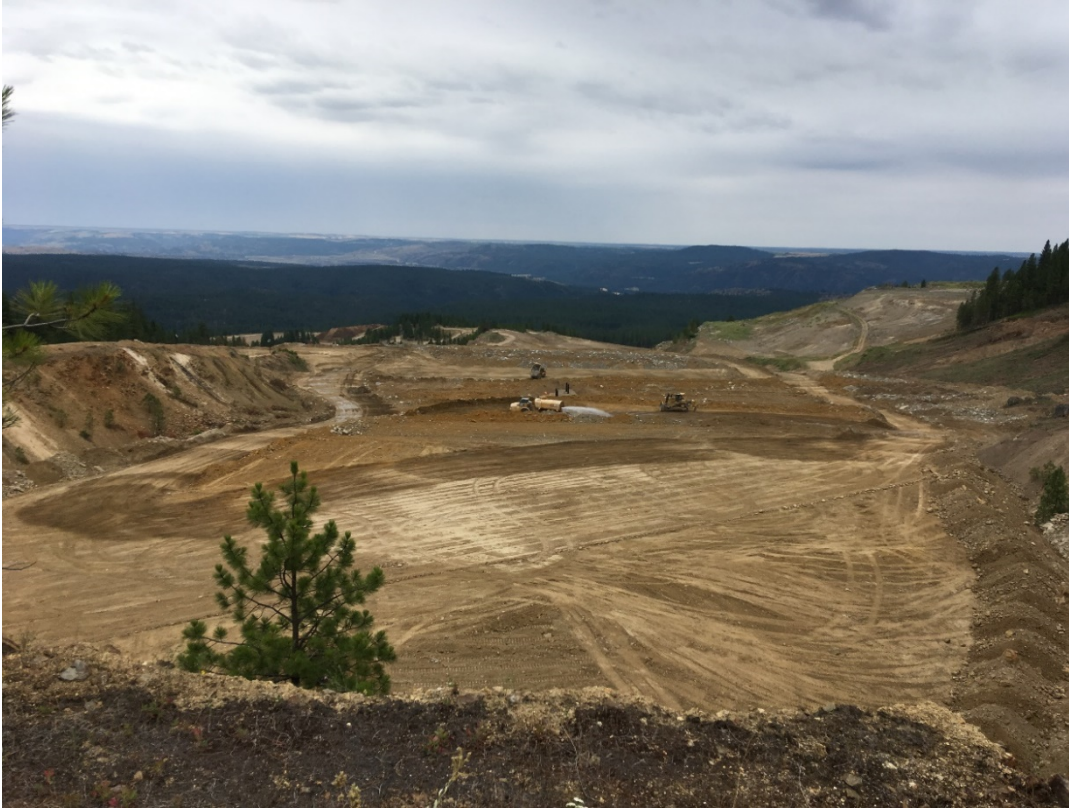
**Figure 1 – Overview of Pit 4, Looking South**

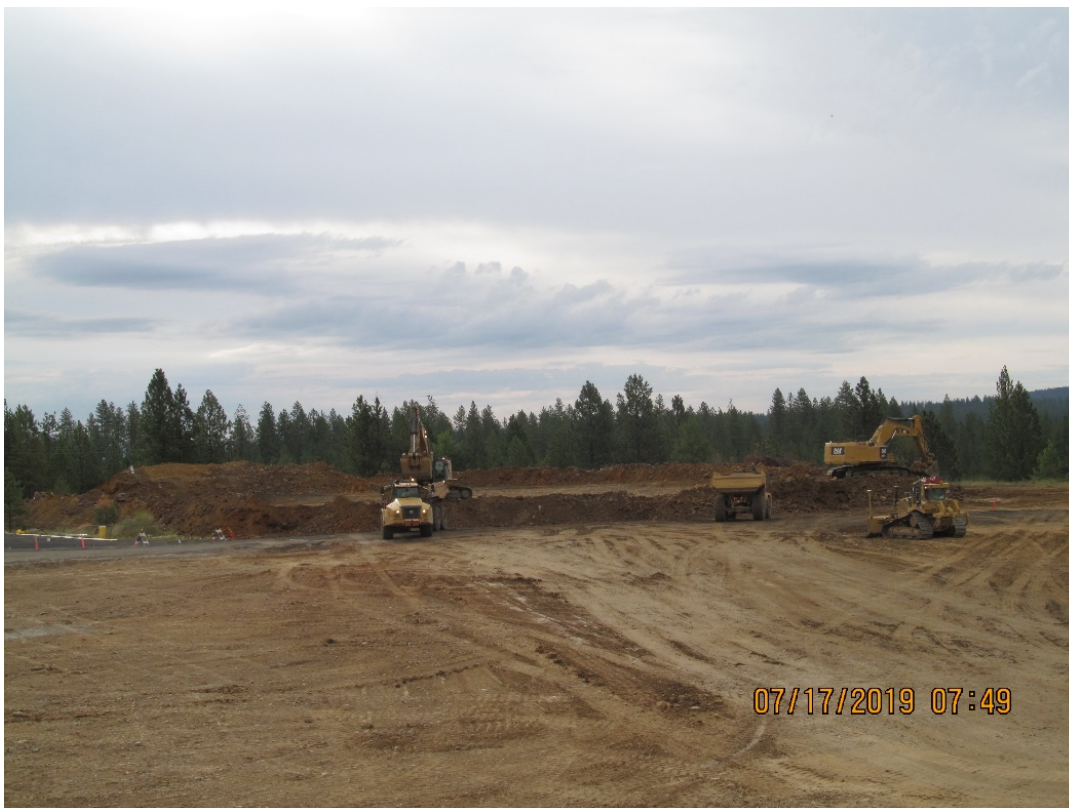
**Figure 2 – Two load-outs at Stockpile 2, Looking Southeast**

- Continued excavating and hauling high activity/high reactivity material from Ore Stockpile 2 (Stockpile 2). High activity/high reactivity material was placed in the unclassified waste zone in the interior of the Pit 4 backfill.

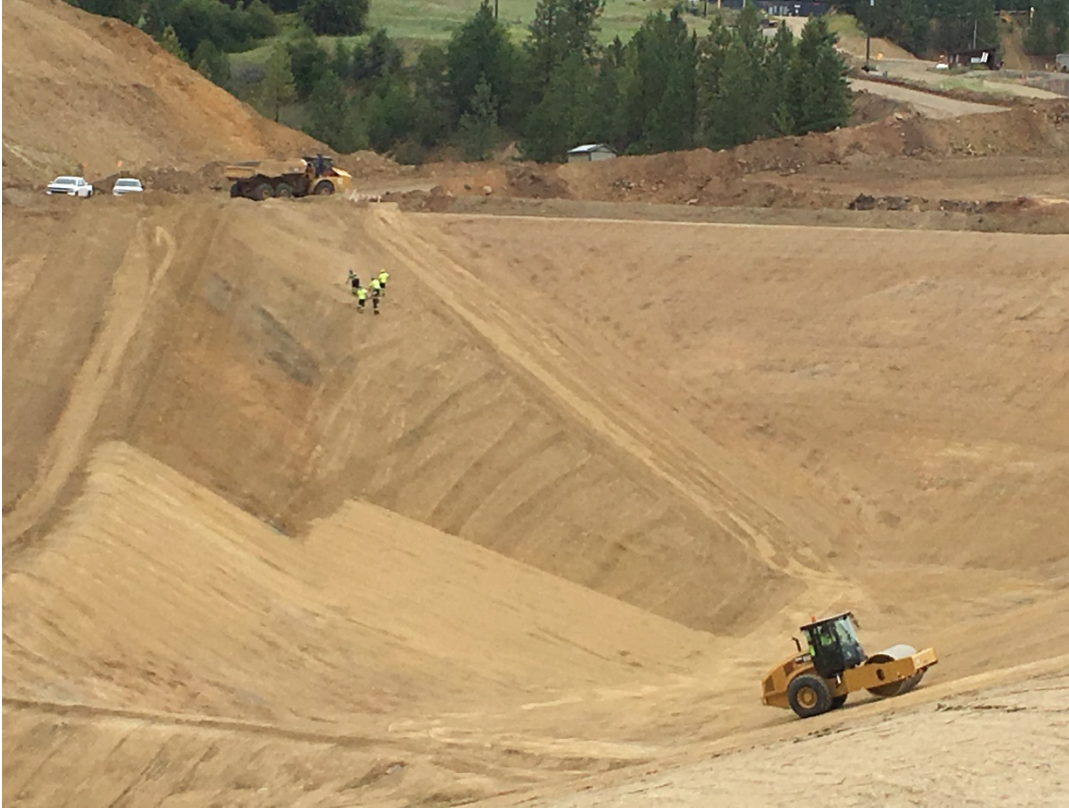
**Figure 3 – Vibratory compactor being used to smooth the South Pond slopes and bottom while the Utility Crew removes unsuitable material from the liner subgrade.**

- Wood Chipping Activities
  - Began chipping stockpiled trees in the south CSZ at the West Gate/New WTP Area on 7/12/2019.
- South Pond
  - Excavated a seep collection sump for the seep located along the northwest side of the pond.
  - Began compacting the pond subgrade with the CS68B smooth drum roller in preparation for the installation of the geomembrane liner system.
- Final Status Surveys
  - ERG collected soil samples and Tetra Tech conducted a gamma survey for both the Class 2 South-Southwest Area and the Pit 4 Tie-in (west side) from 7/15 to 7/17/2019.
